**Flood Control Project Maintenance
Levee Inspections**

Maintenance Issue Types Only, Levee Inspection Report By Mile - Spring 2018

Reclamation District No. 2103 Wheatland Vicinity

Waterway	Bank	Unit Miles	Inspection Start/End	Inspector
Unit No. 01 South Dry Creek	Left	4.64	04/18/2018 04/18/2018	Sterling York

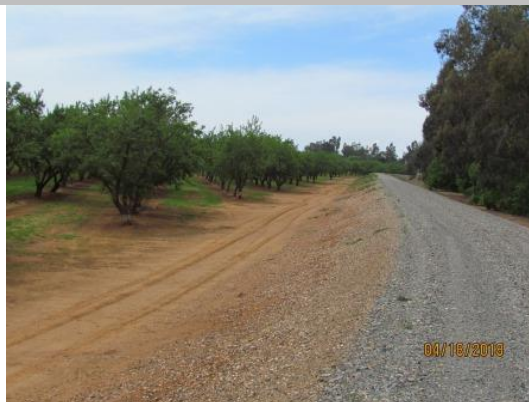
Photo 1 of 1 : SP_2018_RD2103_10_19_20180501_00046.jpg

LM Start	0.01	Rating **	A	Issue No.	19
LM End	4.64	Issue Type +	Ma	Location *	LS
Category	Earthen Levee			GPS Latitude/Longitude	
				Start	End
Item	Vegetation			39.019819 °	39.041198 °
				-121.453903 °	-121.393029 °
DWR ID	DWR_RD2103_01_s_2018_19				
Comment Code					
V1 : Control annual grass and weeds on the levee slopes and easements.					
Inspector Comment					
Annual vegetation is maintained, Spring 2018.

View looking downstream landside of the maintained annual vegetation, Spring 2018.

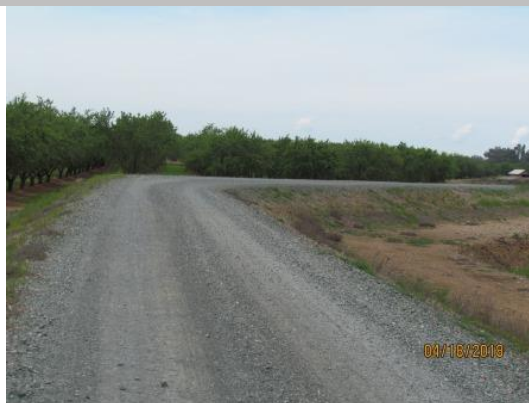
Photo 1 of 1 : SP_2018_RD2103_10_20_20180501_00048.jpg

LM Start	0.01	Rating **	A	Issue No.	20
LM End	4.64	Issue Type +	Ma	Location *	WS
Category	Earthen Levee			GPS Latitude/Longitude	
				Start	End
Item	Vegetation			39.019820 °	39.041197 °
				-121.453903 °	-121.393029 °
DWR ID	DWR_RD2103_01_s_2018_20				
Comment Code					
V1 : Control annual grass and weeds on the levee slopes and easements.					
Inspector Comment					
Annual vegetation is maintained, Spring 2018.

View looking downstream waterside of the maintained annual vegetation, Spring 2018.

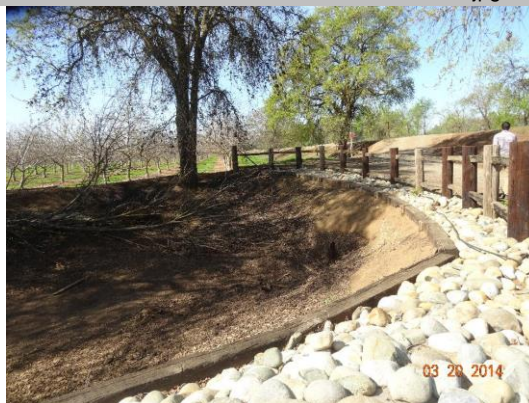
Photo 1 of 3 : UCIP_SP_2018_38325_69869.jpg

LM Start	0.82	Rating **	A/W	Issue No.	36
LM End	0.82	Issue Type +	Ma	Location *	
Category	Supplemental			GPS Latitude/Longitude	
				Start	End
Item	DWR UCIP LMA Responsibility			39.024811 °	39.024811 °
				-121.440750 °	-121.440750 °
DWR ID					
Comment Code					
Inspector Comment					
FS_ID:38325 DS_ID:19471 EP_NO: N/A Repair Type: No Action Needed Crossing Status: Found UCIP Comments: FIELD_STRUCT_DESC: 36-inch corrugated metal drainage pipe through the levee, 14.4 feet below the crown. Concrete headwall, flap-gate, and 3-foot by 6-foot concrete splash apron located on the waterside (WS) toe. Outfall drain from old Grasshopper Slough. [Additional Reference(s): DWR Levee Logs, 2005. USACE Sacramento O&M Manual Unit No. 146, November 1962, (HLM 0.83)] FS Date: 3/20/2014

View of CMP crossing located on landward side.

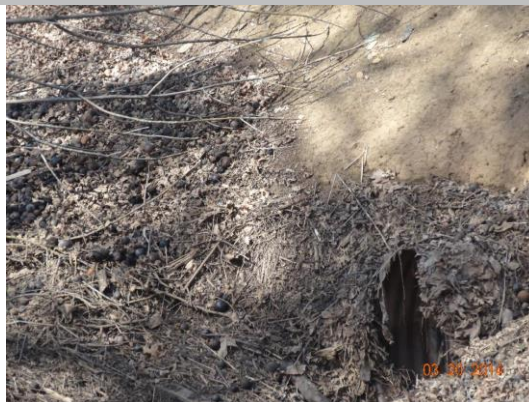
Photo 2 of 3 : UCIP_SP_2018_38325_69868.jpg

Close up view of crossing from landward side.

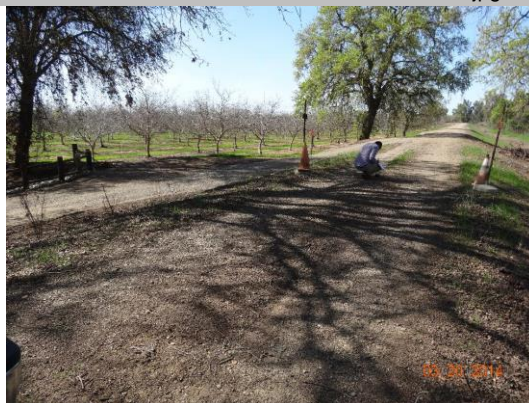
Photo 3 of 3 : UCIP_SP_2018_38325_69873.jpg

View of levee crown at crossing.

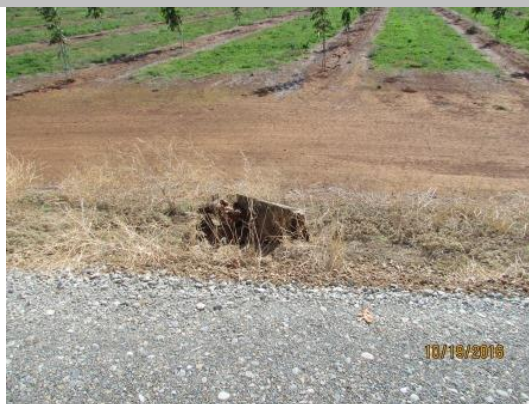
Photo 1 of 1 : SP_2018_RD2103_10_26_20180302_00007.jpg

LM Start	1.27	Rating **	N	Issue No.	26
LM End	1.27	Issue Type +	Ma	Location *	LS
Category	Earthen Levee			GPS Latitude/Longitude	
				Start	End
Item	Trim / Thin Trees			39.027261 °	39.027261 °
				-121.433269 °	-121.433269 °
DWR ID	DWR_RD2103_01_s_2016_26				
Comment Code					
T5 : Tree stumps.					
Inspector Comment					
Stump needs to be removed fom slope.

View of tree stump on lanside levee slope. Fall 2016, still exist as of Fall 2017.

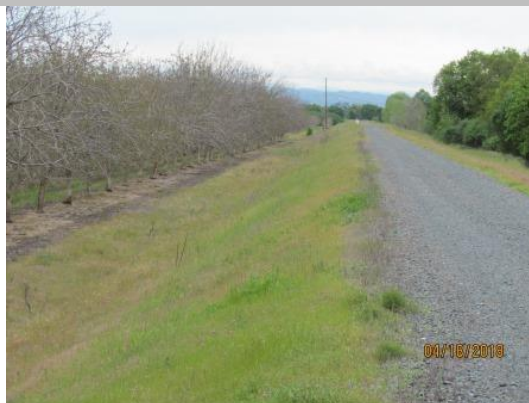
Photo 1 of 1 : SP_2018_RD2103_11_13_20180501_00032.jpg

LM Start	0.00	Rating **	A	Issue No.	13
LM End	4.86	Issue Type +	Ma	Location *	LS
Category	Earthen Levee			GPS Latitude/Longitude	
				Start	End
Item	Vegetation			38.993256 °	39.031514 °
				-121.437688 °	-121.366996 °
DWR ID	DWR_RD2103_02_s_2018_13				
Comment Code					
V1 : Control annual grass and weeds on the levee slopes and easements.					
Inspector Comment					
Annual vegetation is maintained, Spring 2018.

View looking upstream landside of maintained annual vegetation, Spring 2018.

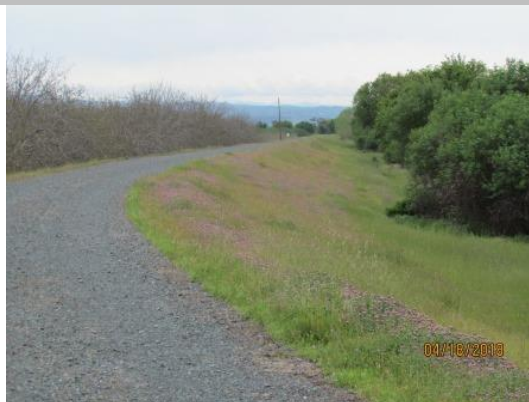
Photo 1 of 1 : SP_2018_RD2103_11_14_20180501_00033.jpg

LM Start	0.00	Rating **	A	Issue No.	14
LM End	4.86	Issue Type +	Ma	Location *	WS
Category	Earthen Levee			GPS Latitude/Longitude	
				Start	End
Item	Vegetation			38.993256 °	39.031514 °
				-121.437689 °	-121.366996 °
DWR ID	DWR_RD2103_02_s_2018_14				
Comment Code					
V1 : Control annual grass and weeds on the levee slopes and easements.					
Inspector Comment					
Annual vegetation is maintained, Spring 2018.

View looking upstream waterside of maintained annual vegetation, Spring 2018.

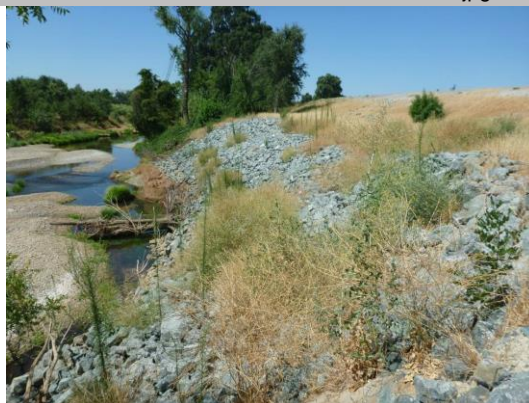
Photo 3 of 5 : LEVAL_SP_2018_488_1808.jpg

Description: 2017 Flood Fight Emergency Repair - 200 feet of site repaired in March 2017. Additional 50 feet requires repair after water receded. \$220,000 estimated total for completion and post project permits and mitigation

Notes: Site will likely degrade quickly due to lack of RSP along the lower portion of the bank slope and downstream end of site. At time of field visit, site does not appear to be any imminent threat of failure.

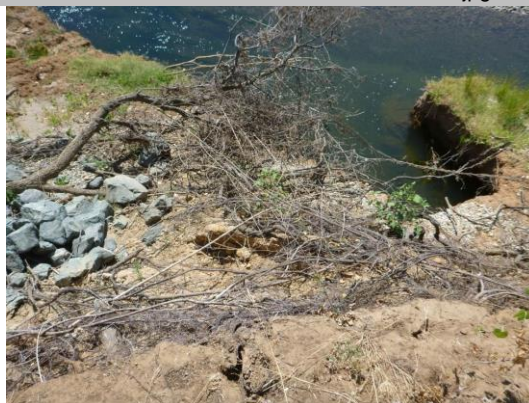
Photo 5 of 5 : LEVAL_SP_2018_488_1812.jpg

Comment Code					
Inspector Comment					
<p>Levee Evaluation Comments</p> <p>Description: 2017 Flood Fight Emergency Repair - 200 feet of site repaired in March 2017. Additional 50 feet requires repair after water receded. \$220,000 estimated total for completion and post project permits and mitigation</p> <p>Site ID No: 488</p> <p>Site Designation: LMA-326</p> <p>Repair Type: Erosion</p> <p>Rating: Area of Concern</p> <p>Field Date: 7/27/2017</p> <p>Notes: Site will likely degrade quickly due to lack of RSP along the lower portion of the bank slope and downstream end of site. At time of field visit, site does not appear to be any imminent threat of failure.</p>
